**I-76 NB RAMPS TO HIGHWAY 2**

# MODIFIED ENVIRONMENTAL SITE ASSESSMENT

May 2021

Prepared for:  
City of Commerce City

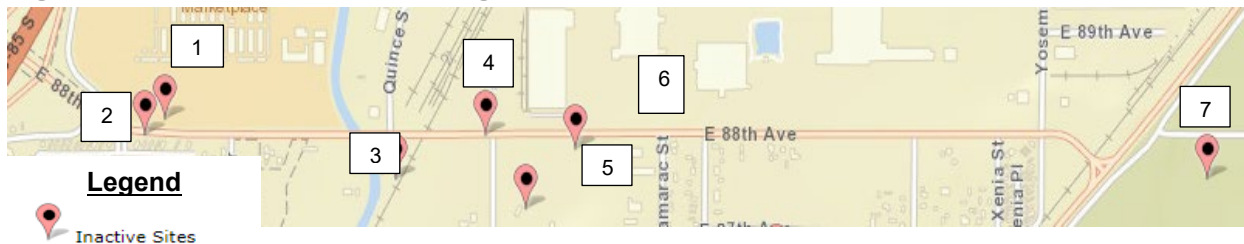
**Figure 5. Groundwater Monitoring Wells**

Research was completed to determine the depth of groundwater below ground surface. This was completed by referencing a USGS Water Resource map that includes information on active and inactive groundwater monitoring wells throughout the State of Colorado (USGS, 2018a). Figure 5 depicts the locations of seven monitoring wells that are near the project study area. The seven wells have been inactive and abandoned for over 60 years; however, the data last collected had an average depth of 32.4 feet below surface level (Table 1). Based on this information, the data depicted in Table 1 may not reflect current groundwater levels. During site reconnaissance, no wells were observed within the project study area. This reconnaissance was limited to areas with public access and within right-of-way.

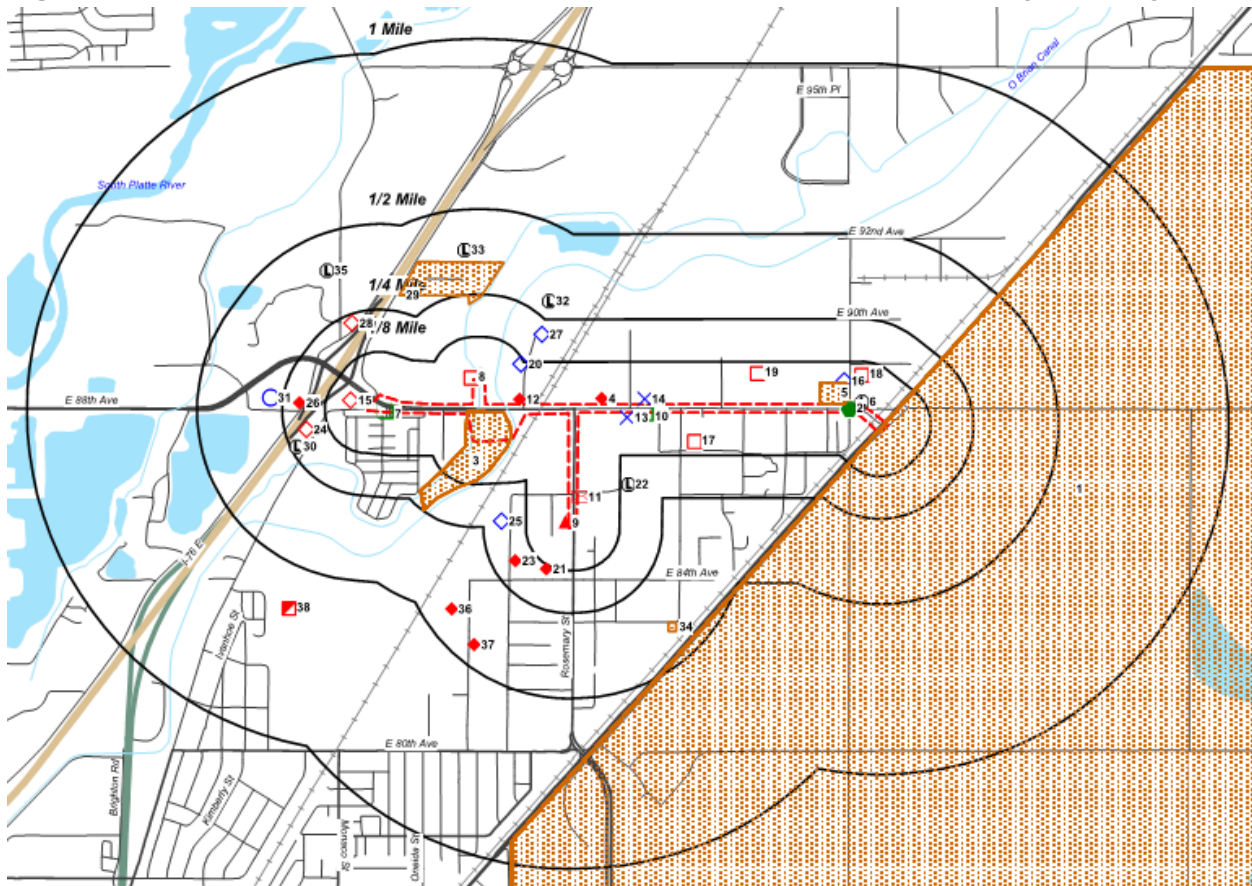
Figure 6. Sites with Potential Hazardous Concerns Within 1.0 Mile of Project Study Area

In total, the GeoSearch report identified 38 sites with 190 records of potential hazardous concerns, as shown in Figure 6. Of the 190 records, 101 are federal, 89 are state, and 0 are local or tribal.

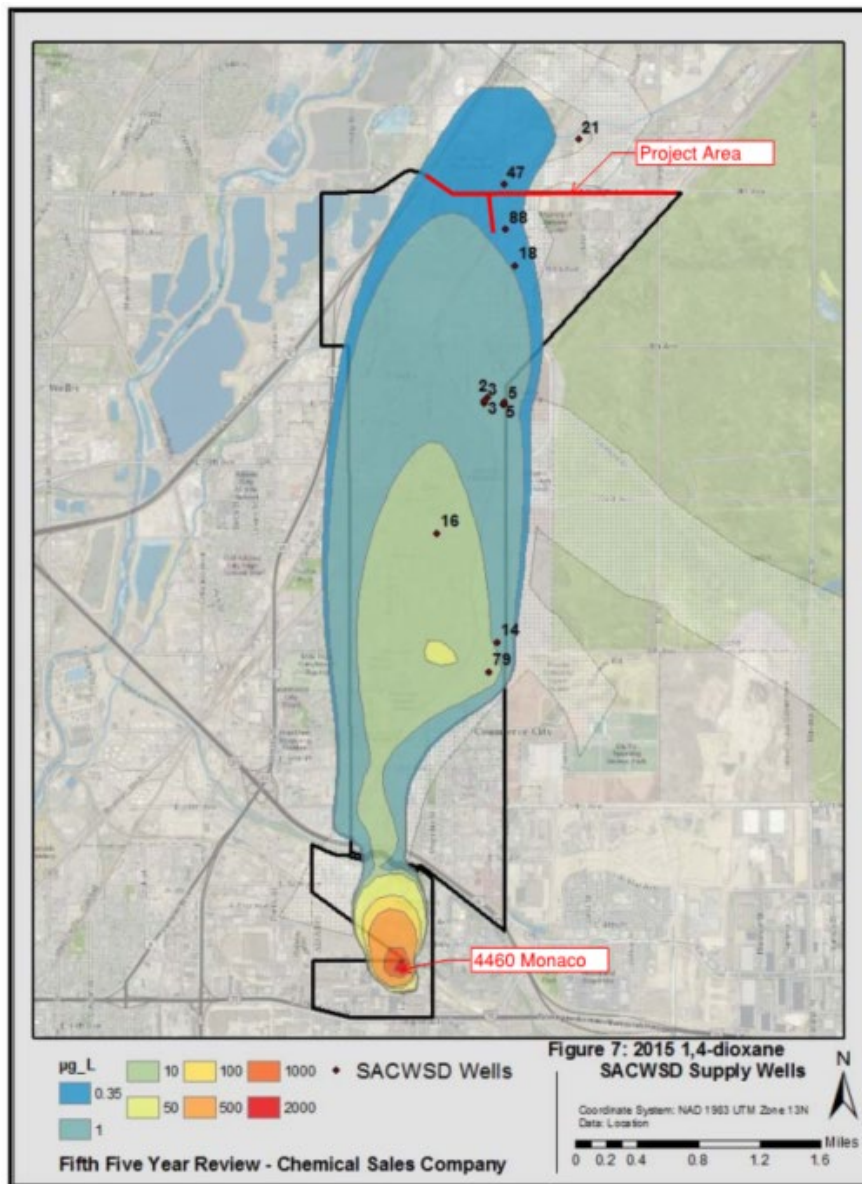
Figure 7. Site 4460 Monaco Chemical Sales Wells

dioxane, and other contaminants and extend north from the site. Groundwater plumes with TCE and PEC extend north roughly to E. 56th Avenue. Groundwater plumes with 1,4-dioxane have been remediated and tested within operable unit 2, which extends to E 88th Avenue. Figure 7 illustrates the 1, 4 dioxane plume extending through the western half of the project study area and adjacent South Adams County Water and Sanitation District potable water supply wells. Wells 88 and 47 are closest to the project study area and have been tested over five years (2012 to 2017). Data collected from the water sources closest to the study area reflect an average of 0.35 µg/L 1,4 dioxane levels, USI PA RSI states the levels should not exceed 0.46 µg/L and calculated risks for 1, 4 dioxane fall within acceptable risk range within the study area (Appendix B). Due to its location, this site was not identified in the GeoSearch Report. CDOT provided the Fifth Five Year Review Report for the Chemical Sales Co. Superfund Site (CDPHE, 2017) for consideration.
